Engineering - Landscape Architecture - Surveying

Project Name	24016 Middle Village CDD		
Prepared By	Branden J Marcinell		
Date Of Visit	06/09/2025 12:41 PM EDT		
Date Prepared	06/23/2025 EDT		
Weather	Cloudy	Temp	91
Site Conditions		Date of Last Report	N/A
Present at Site

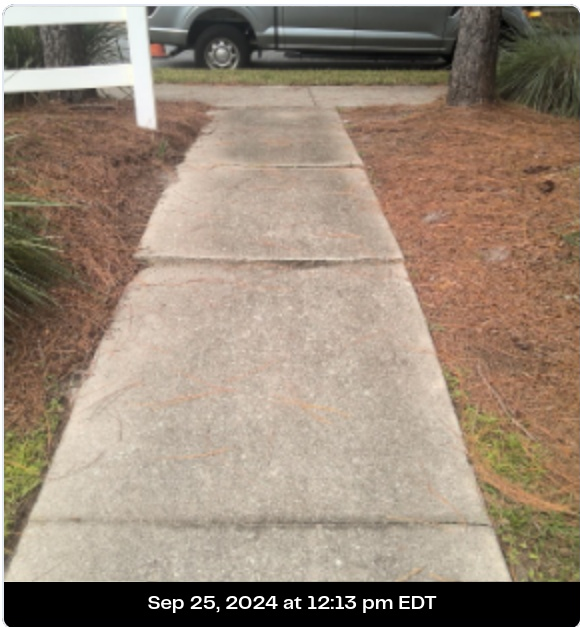
Raised edge on sidewalk, trip hazard.

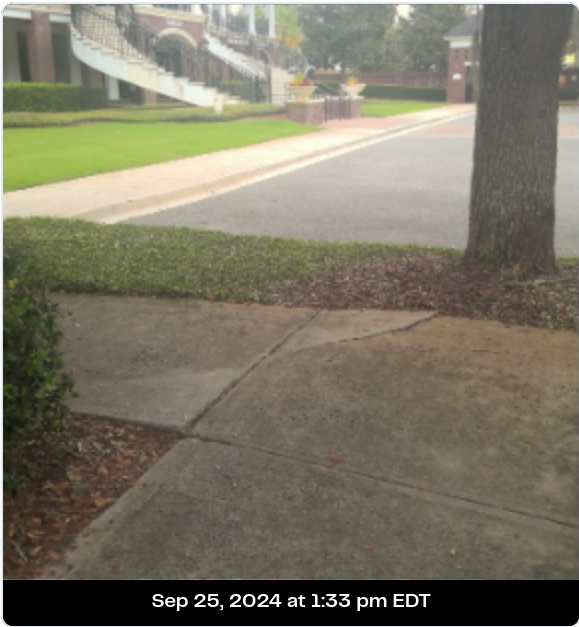
Ryan Morgan September 25, 2024 1:33 PM EDT
Raised sidewalk edge from tree rooting, trip hazard.

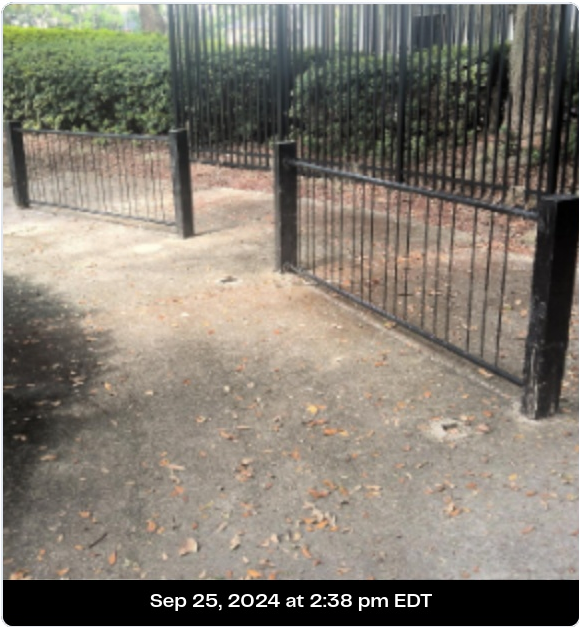
Ryan Morgan September 25, 2024 2:38 PM EDT
Bike rack loose. Post hole depressions in concrete, trip hazard.

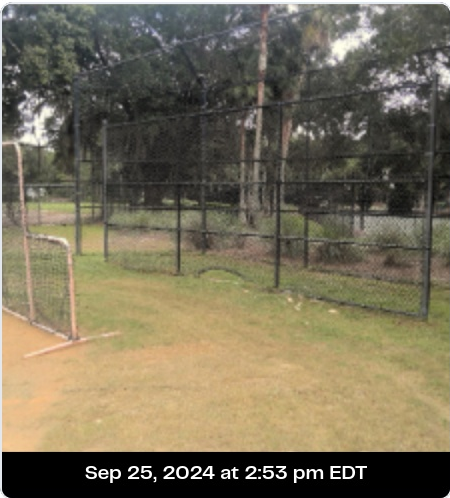
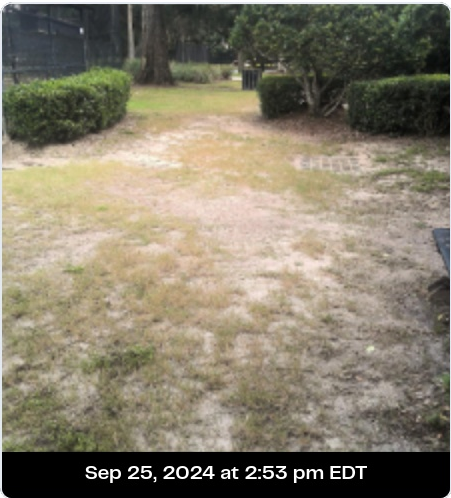
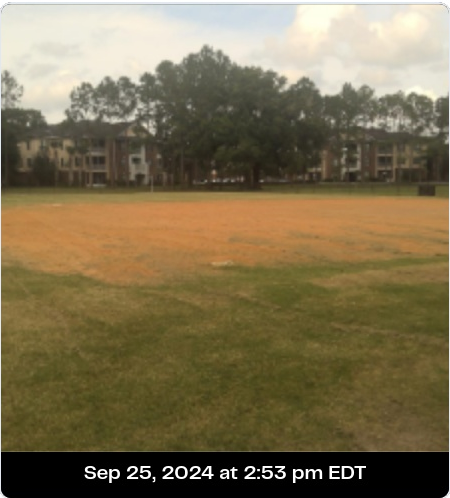
Ryan Morgan September 25, 2024 2:53 PM EDT
Fence and backstop fence damaged, broken bench.

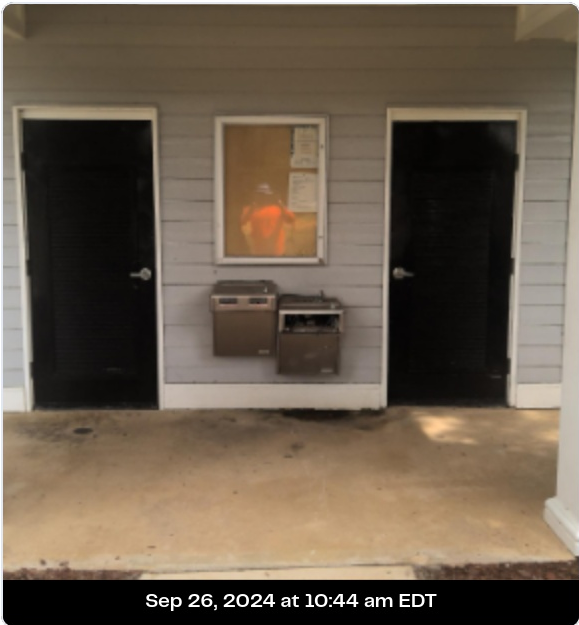
Water fountains damaged, inoperable.

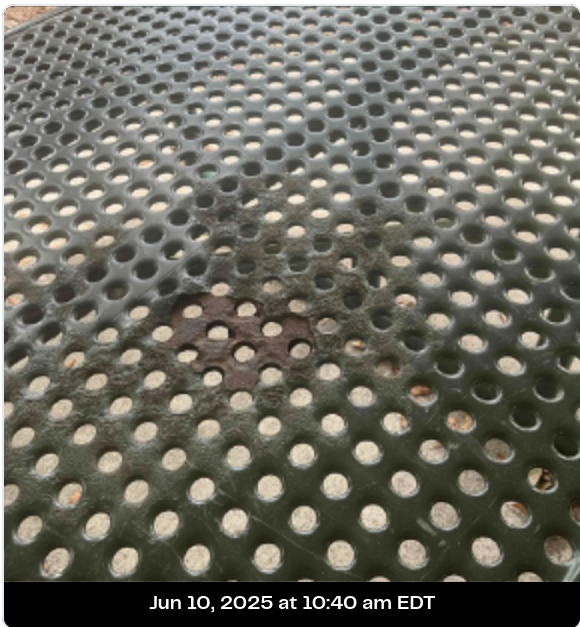
Branden J Marcinell June 10, 2025 10:41 AM EDT
Rust on picnic table, paint delaminating. observe for worsening condition.

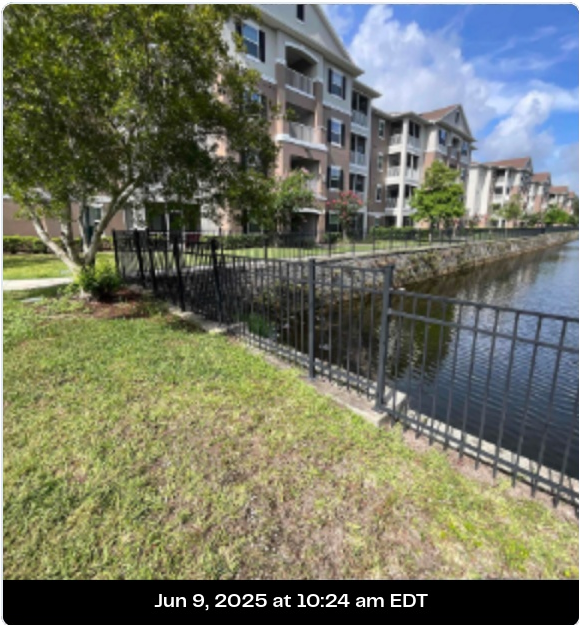
Railing loose. Suggest repair to resecure.

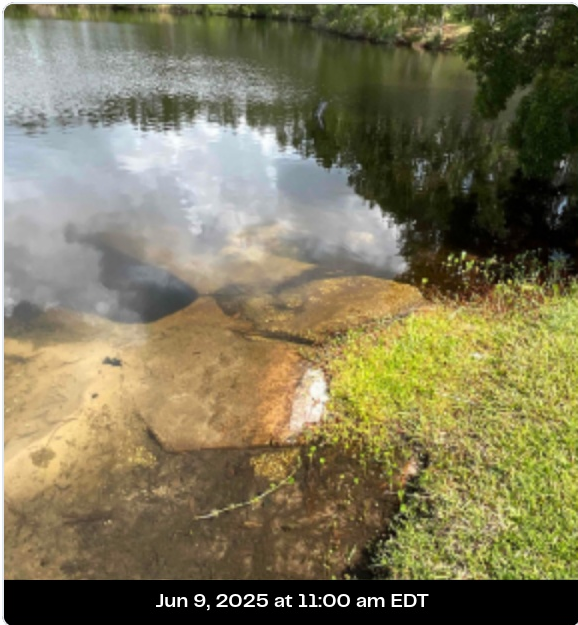
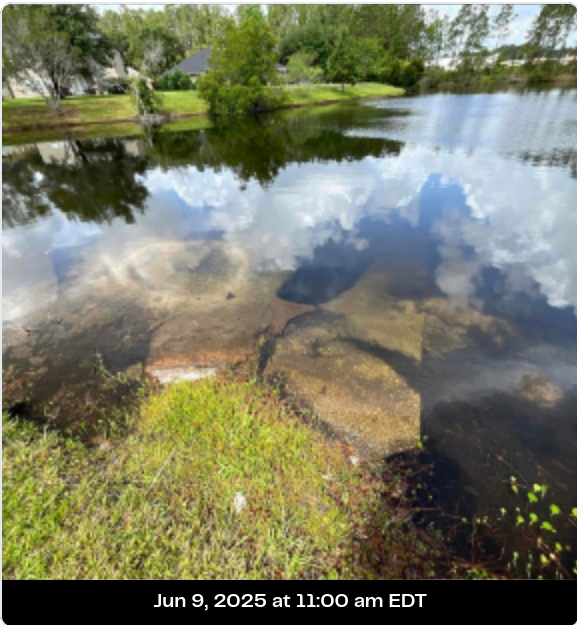
Branden J Marcinell June 9, 2025 11:01 AM EDT
Control structure MES in pond cracking surface concrete. Observed at future inspections.

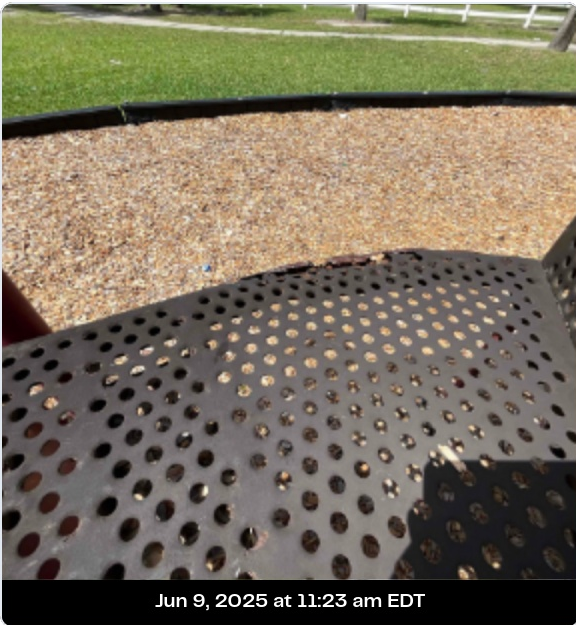
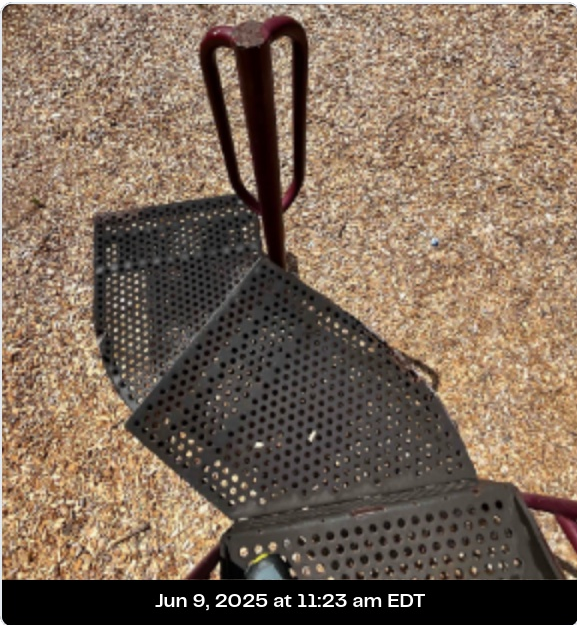
Branden J Marcinell June 9, 2025 11:24 AM EDT
Expose rusted metal on landing. Landing flexes under adult load. Protect against sharp edges.

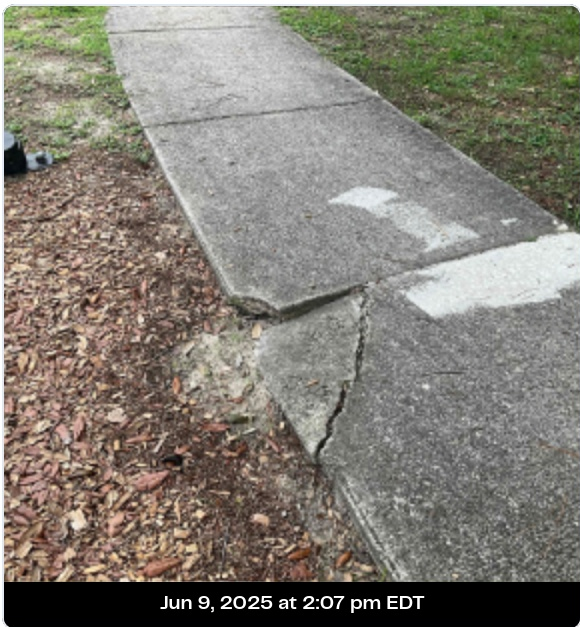
Broken concrete creating a trip hazard. Replaced sidewalk segment to repair damaged area flush to existing concrete.

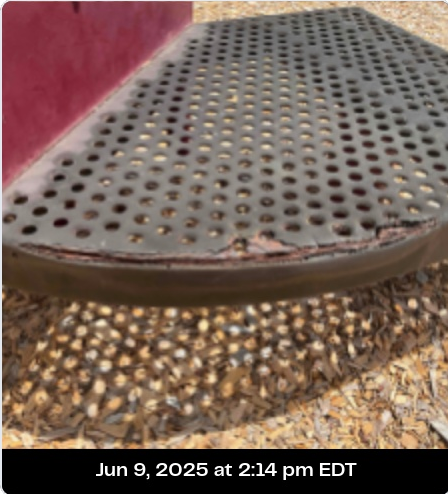
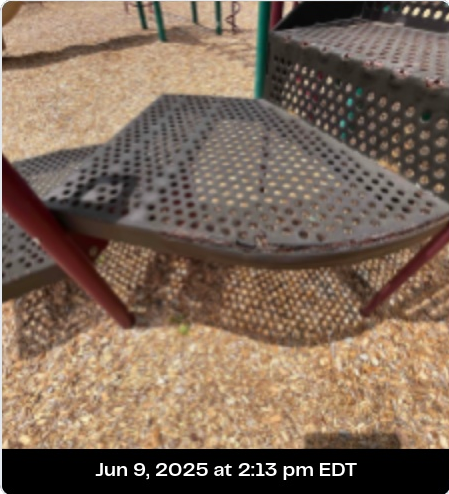
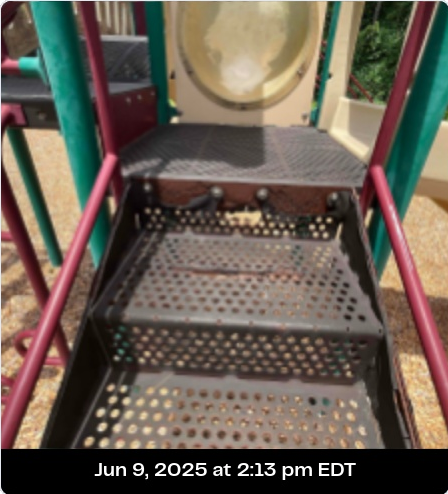
Exposed rusted metal on landing. Landing flexes under adult load. Multiple areas showing exposed rust and sharp edges. Advise protection against sharp edges.

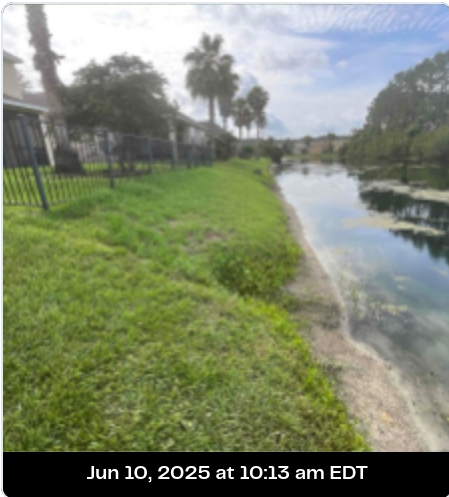
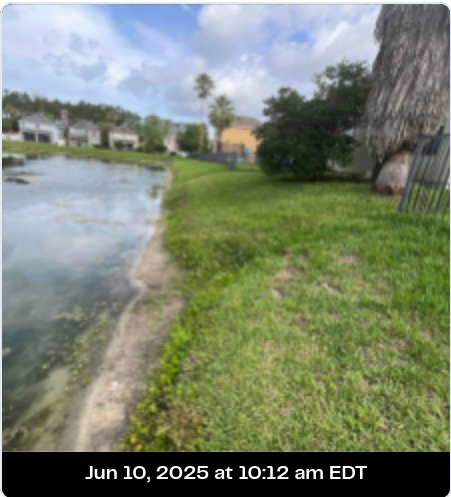
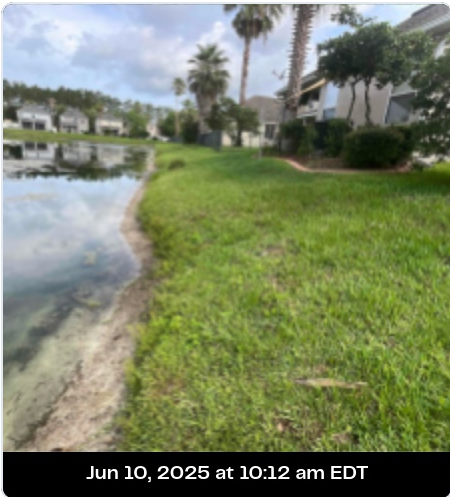
Large grade change at pond Bank. Multiple locations of erosion at property lines. Needs to be addressed due to the level of erosion observed.

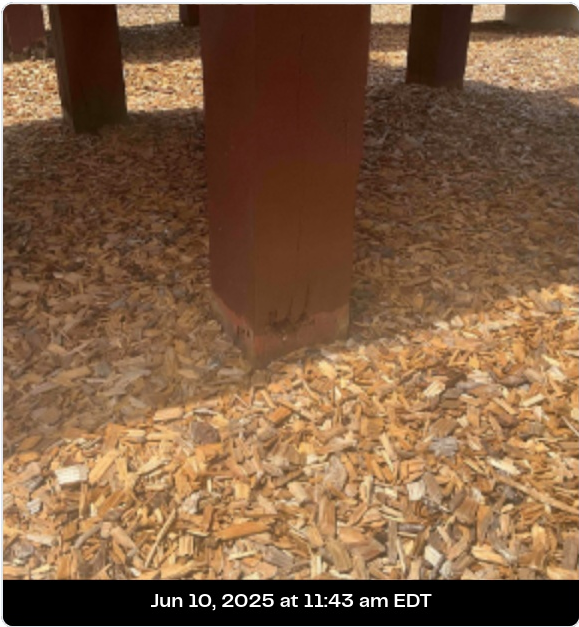
Branden J Marcinell June 10, 2025 11:44 AM EDT
Wooden support post in early stages of rot. Observe at future inspections for stability.

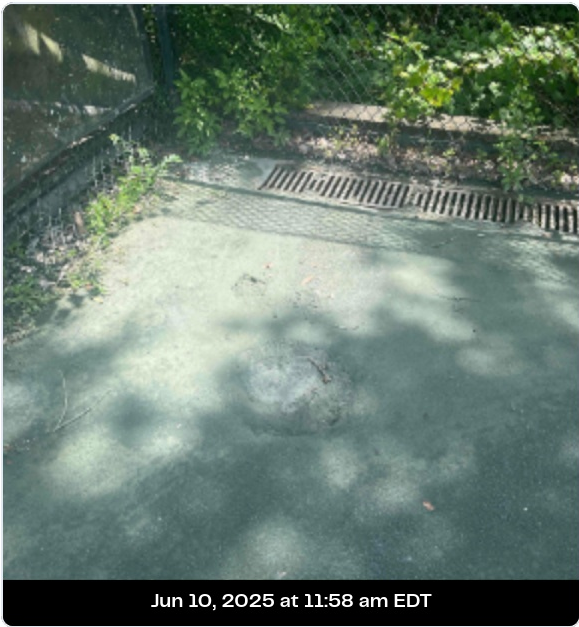
Branden J Marcinell June 10, 2025 12:02 PM EDT
Soft spot in clay surface. Repair / investigate cause.

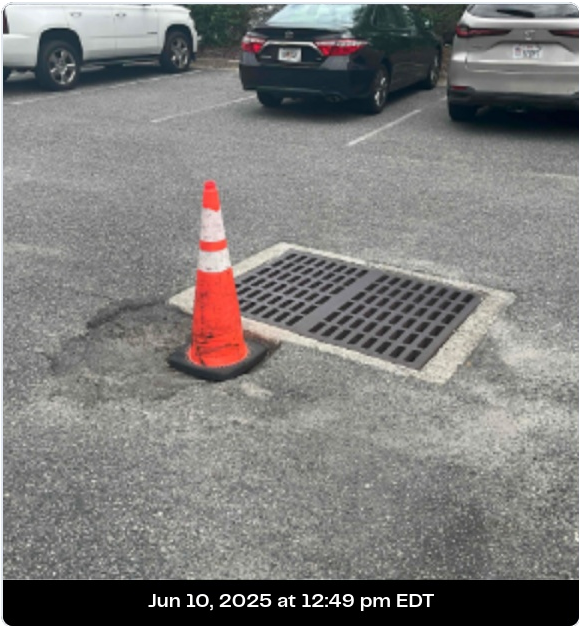
Pot hole next to inlet and parking lot. Possible issue with pipe underground. Patch hole with pavement or investigate cause for complete repair.

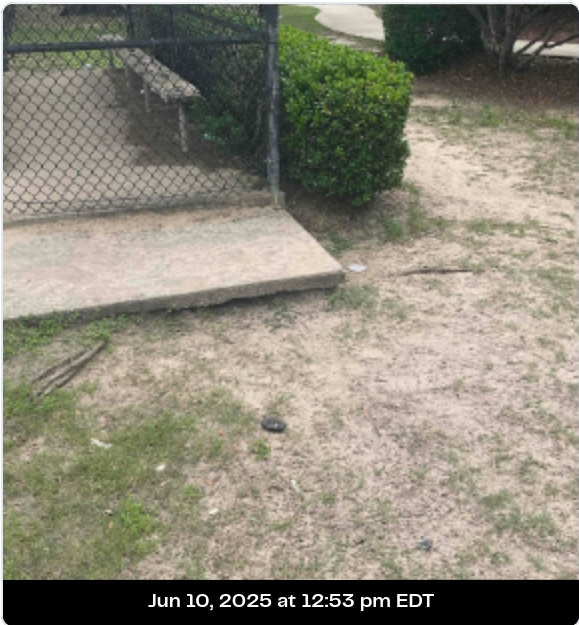
Concrete pad being undermine suggest fill and stabilize around corner to protect against cracking and erosion.

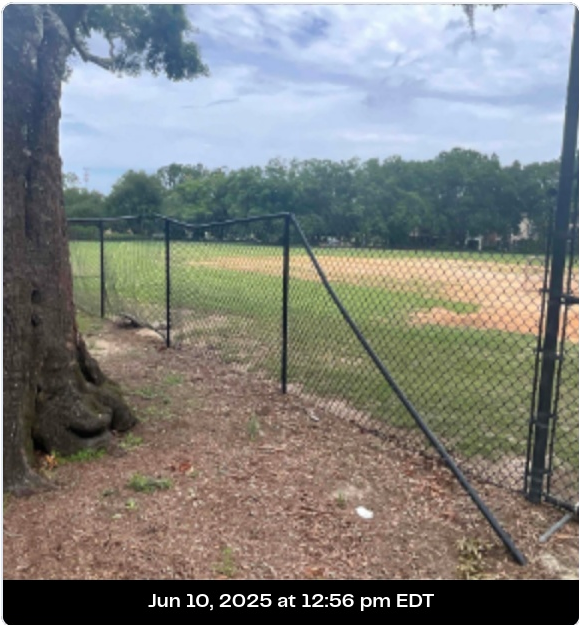
Branden J Marcinell June 10, 2025 12:57 PM EDT
Fence support down and broken. Repair and reattach for stability.

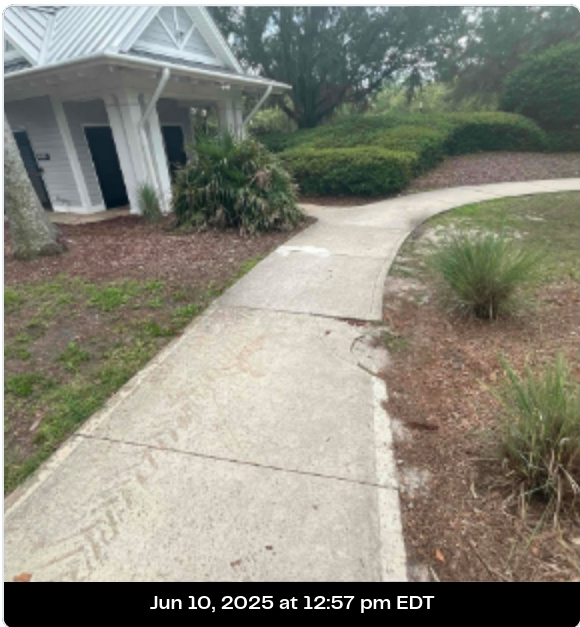
Broken sidewalk with trip hazard. Repair flush with existing sidewalk.

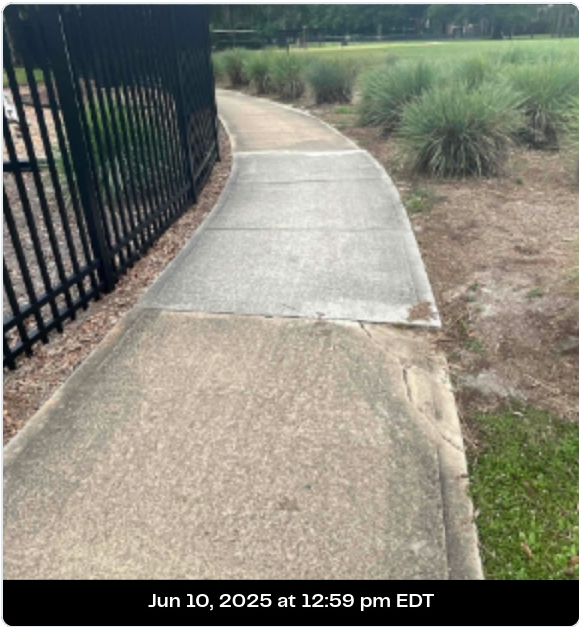
Branden J Marcinell June 10, 2025 12:59 PM EDT
Broken sidewalk with trip hazard. Repair flush with existing sidewalk.

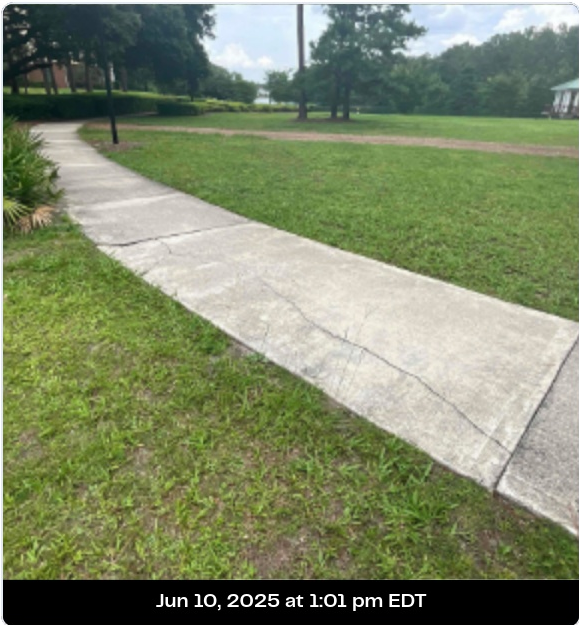
Broken sidewalk with trip hazard. Repair flush with existing sidewalk.

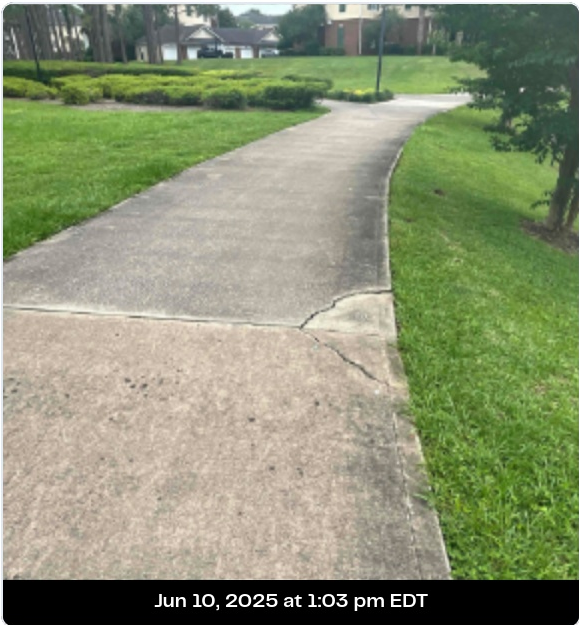
Branden J Marcinell June 10, 2025 1:03 PM EDT
Broken sidewalk with trip hazard. Repair flush with existing sidewalk.

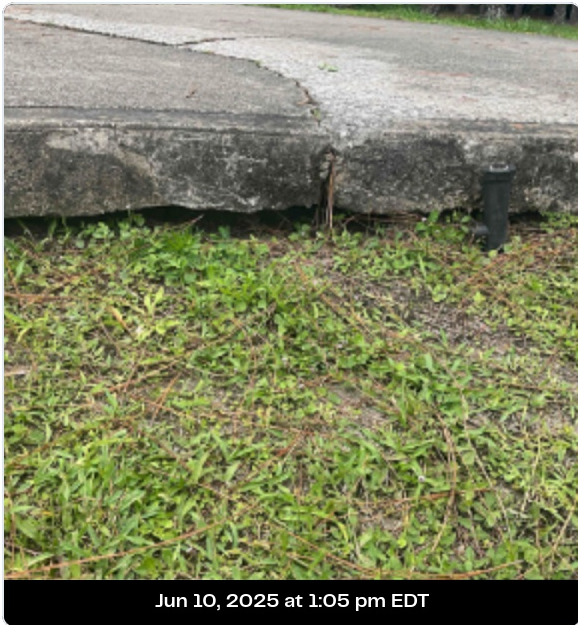
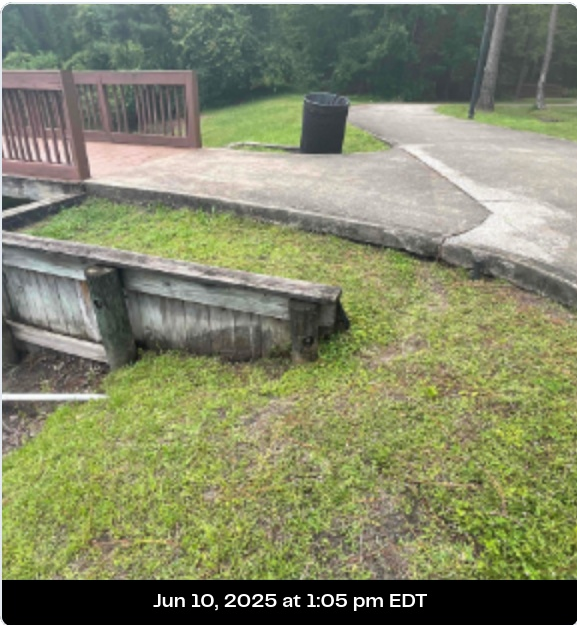
Branden J Marcinell June 10, 2025 1:06 PM EDT
Erosion underneath sidewalk. Backfill to protect against settling and separation or monitor for worsening condition.
