Engineering - Landscape Architecture - Surveying

Project Name	24016 Middle Village CDD		
Prepared By	Branden J Marcinell		
Date Of Visit	06/09/2025 12:41 PM EDT		
Date Prepared	06/23/2025 EDT		
Weather	Cloudy	Temp	91
Site Conditions		Date of Last Report	N/A
Present at Site

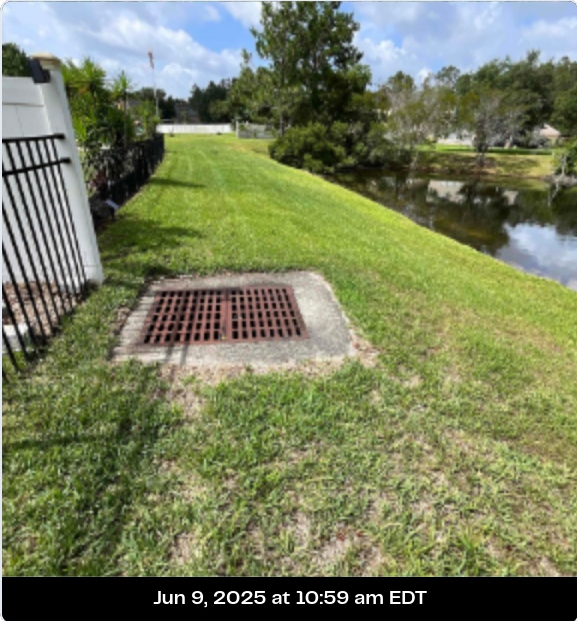
1

Branden J Marcinell June 9, 2025 10:59 AM EDT
Control structure functioning as designed.

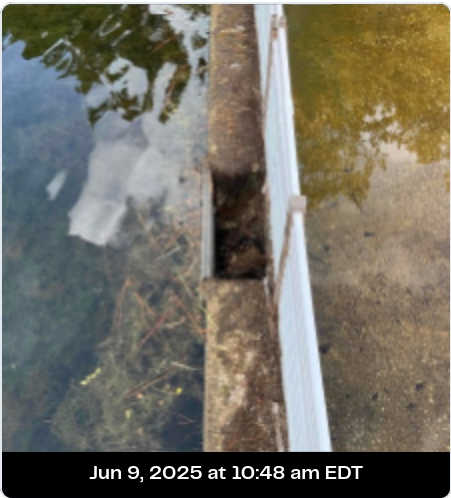
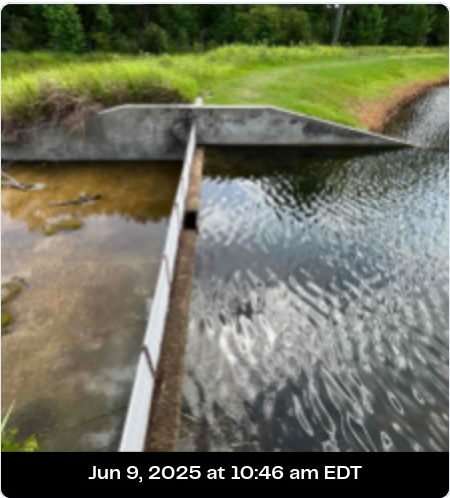
2

Branden J Marcinell June 9, 2025 10:48 AM EDT
Weir blocked by vegetation and not functioning correctly. Remove vegetation and clean weir great as needed.

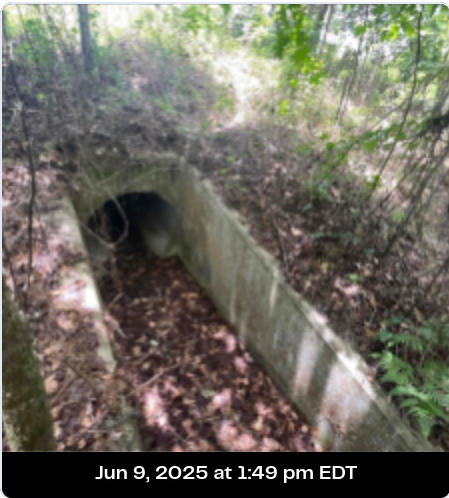
3

Branden J Marcinell June 9, 2025 1:50 PM EDT
Control structure operating as designed. Advise removing debris to make sure it does not clog during operation at high volume.

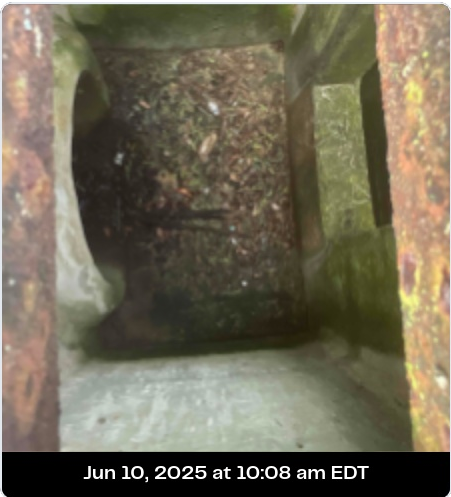
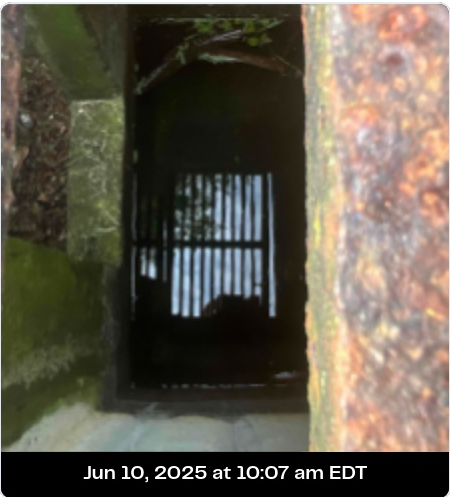
4

Branden J Marcinell June 10, 2025 10:09 AM EDT
Control structure operating as per design. Debris buildup on downstream side of weir. Erosion in pond bank present near control structure. Needs to be addressed.

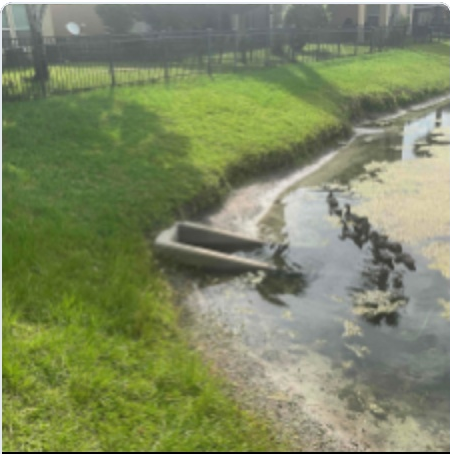
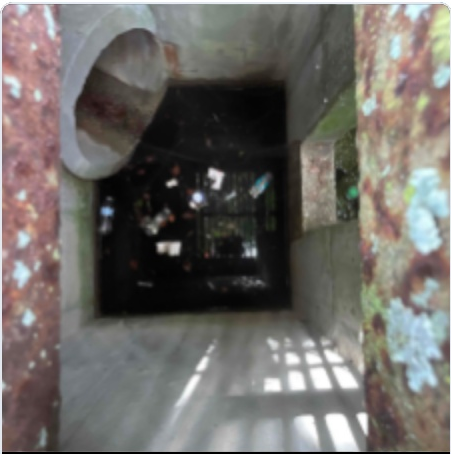
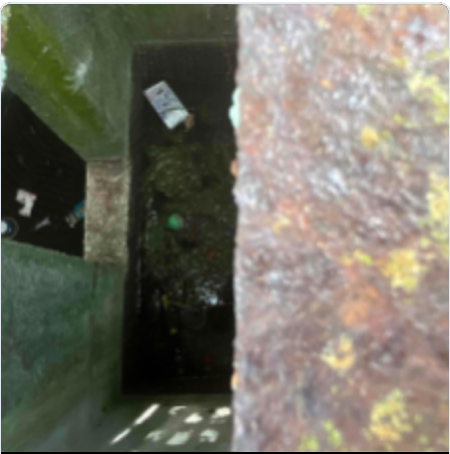
5

Branden J Marcinell June 10, 2025 10:03 AM EDT
Control structure functioning as designed.

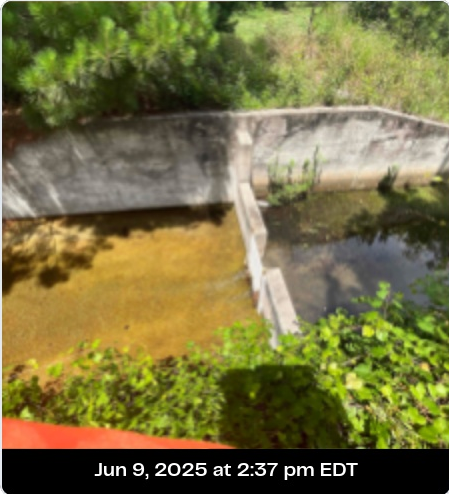
6

Branden J Marcinell June 9, 2025 2:38 PM EDT
Control structure operating as designed. Some debris has gathered in the skimmer. Suggest cleaning regiment regularly to avoid clogging.

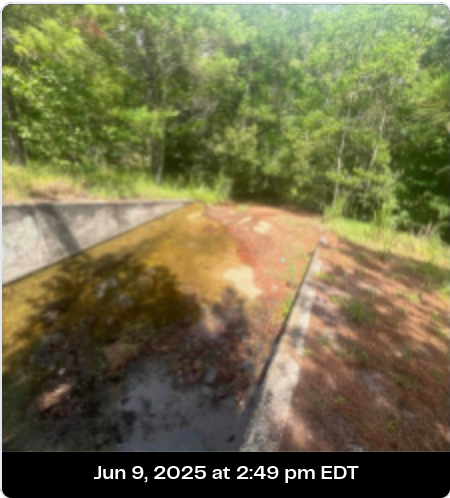
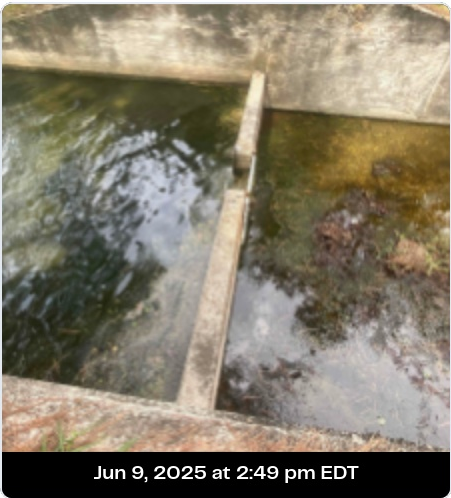
7

Soil/Vegetation on downstream side of weir needs to be cleared. Clean organics and debris from skimmer.

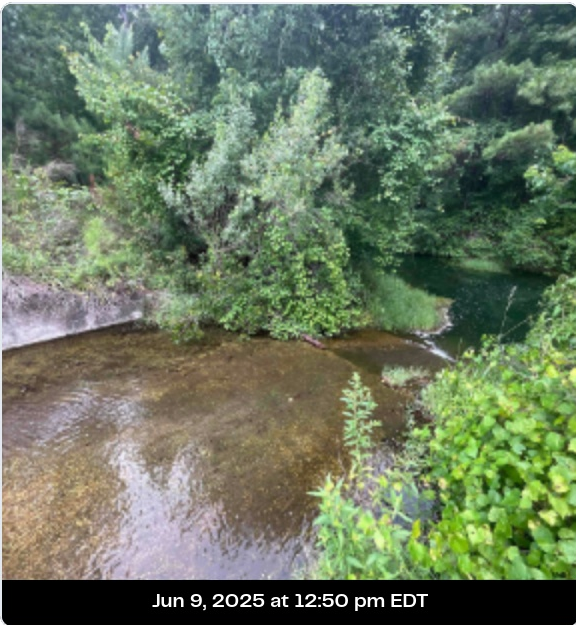
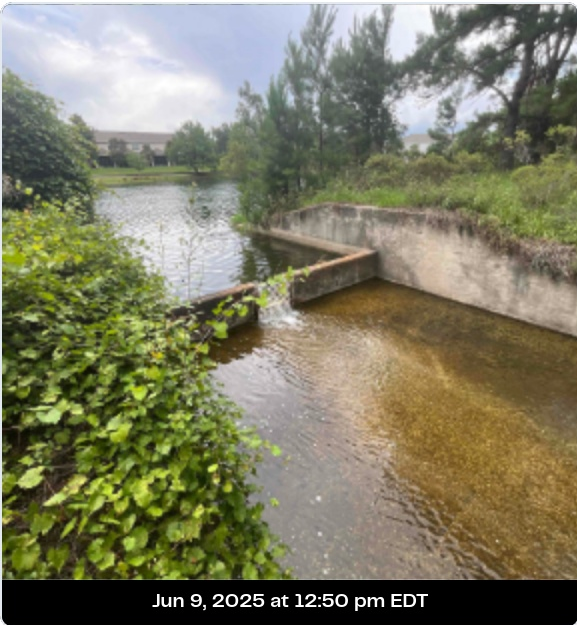
8

Branden J Marcinell June 9, 2025 12:51 PM EDT
Weir is functioning as designed.

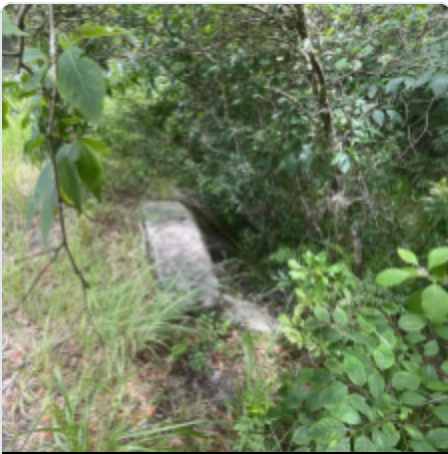
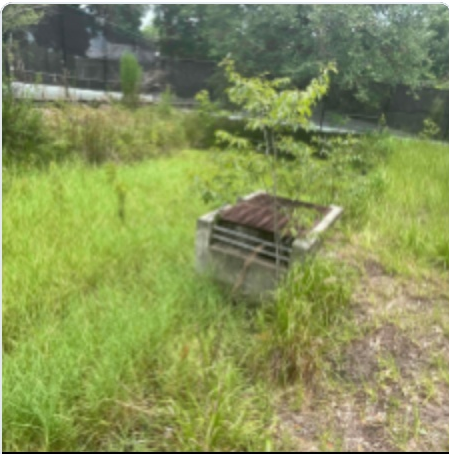
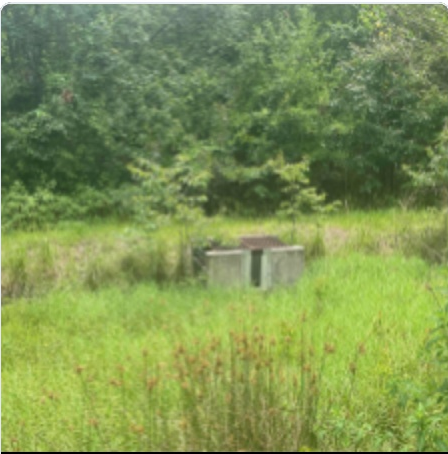
Branden J Marcinell June 9, 2025 1:13 PM EDT
Control structure operating as designed.

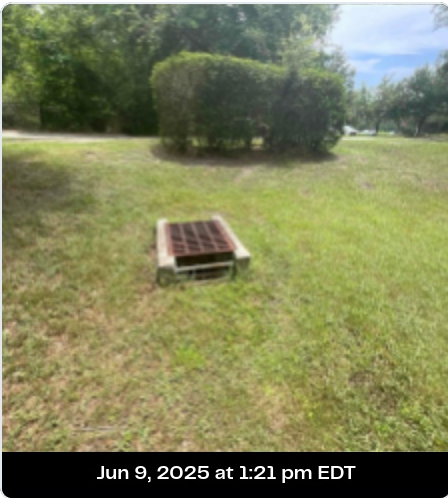
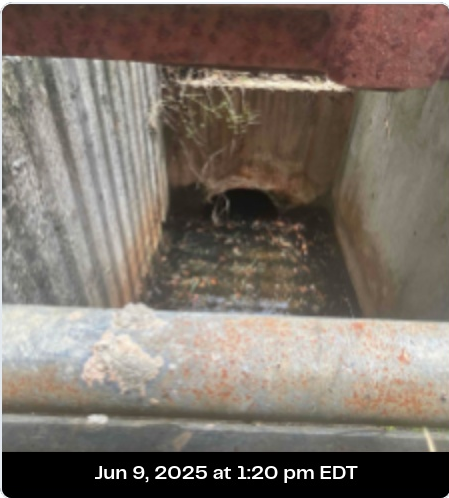
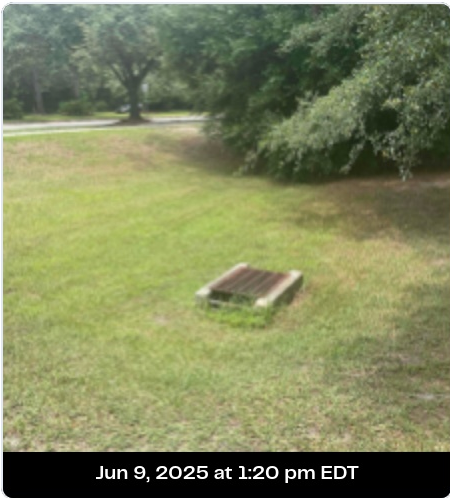
Control structure in retention area, system is charged.

Branden J Marcinell June 9, 2025 1:21 PM EDT
Control structure in retention area, system is charged.

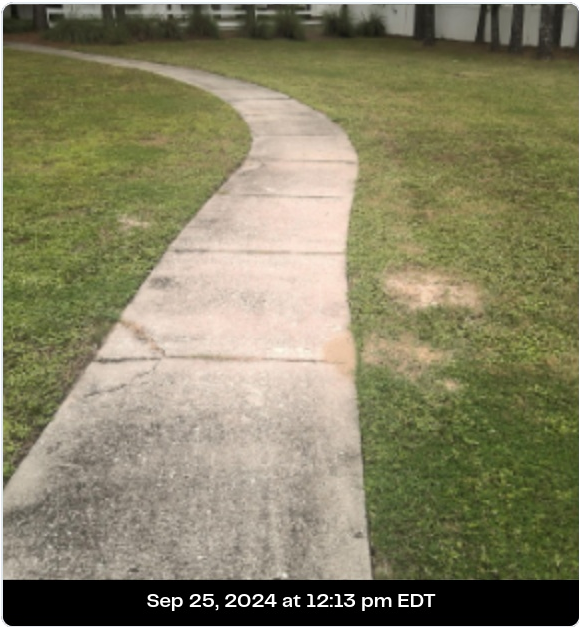
12

Corrective action in progress

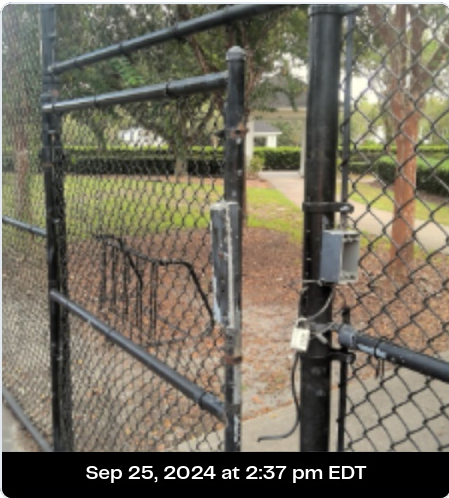
14

Mike Silverstein May 2, 2025 1:05 PM EDT
Corrective action is in progress

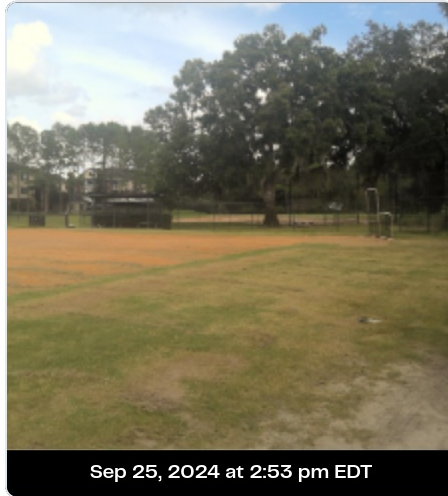
16 **42** Fence and backstop fence damaged, broken bench.

Ryan Morgan September 25, 2024 2:53 PM EDT
Fence and backstop fence damaged, broken bench.

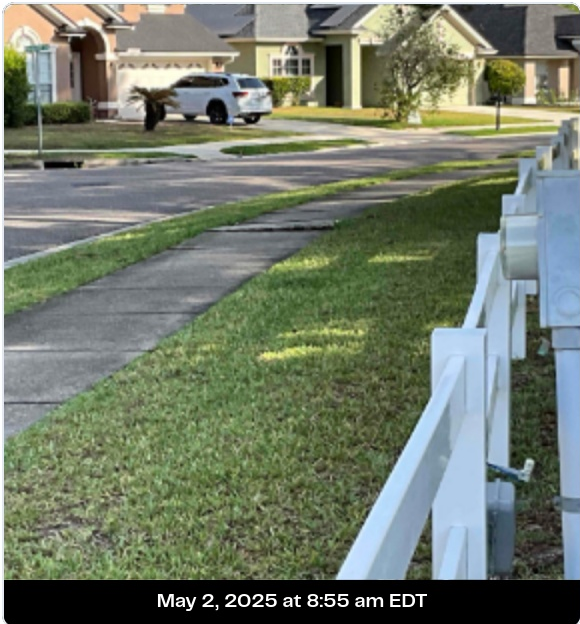
CDD will contact Clay County for corrective action. Clay County has instructed CDD to report sidewalk issues within ROW per JS-facilities manager.

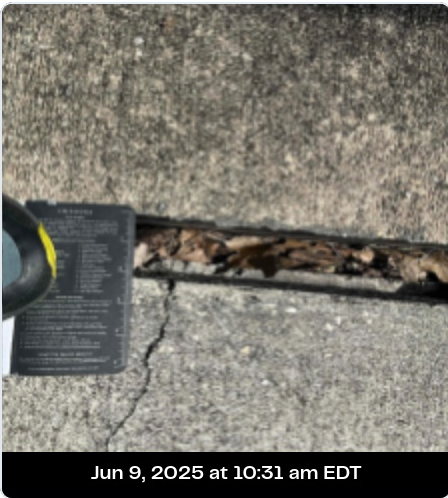
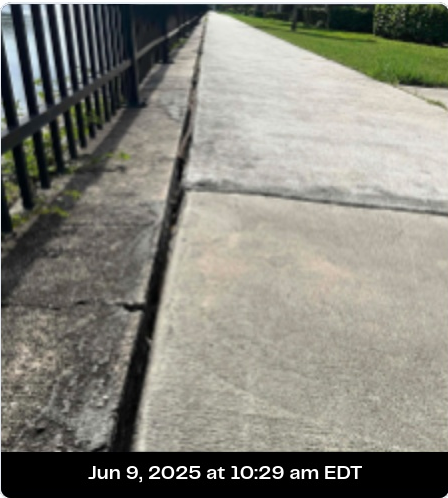
Retaining wall separating from walkway. Advised inspection for safety.

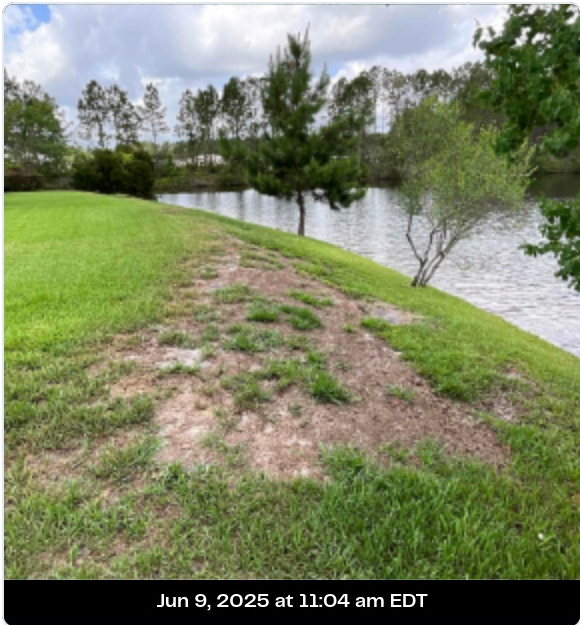
Branden J Marcinell June 9, 2025 11:04 AM EDT
Dead vegetation on Pond Bank. Reestablish vegetation to stabilize and protect against erosion.

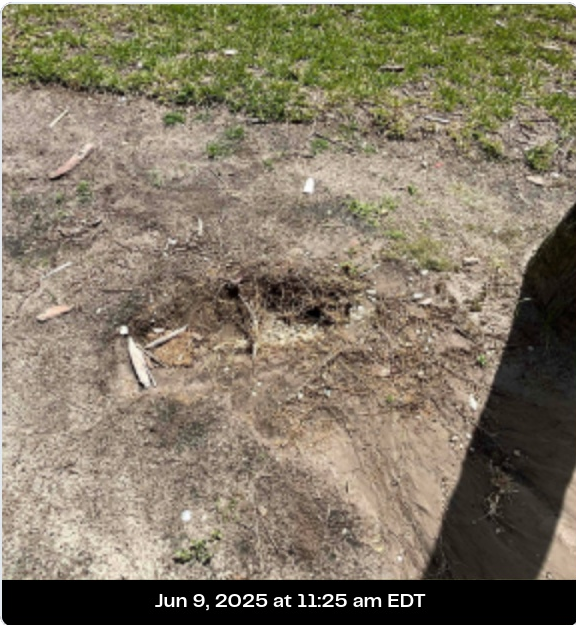
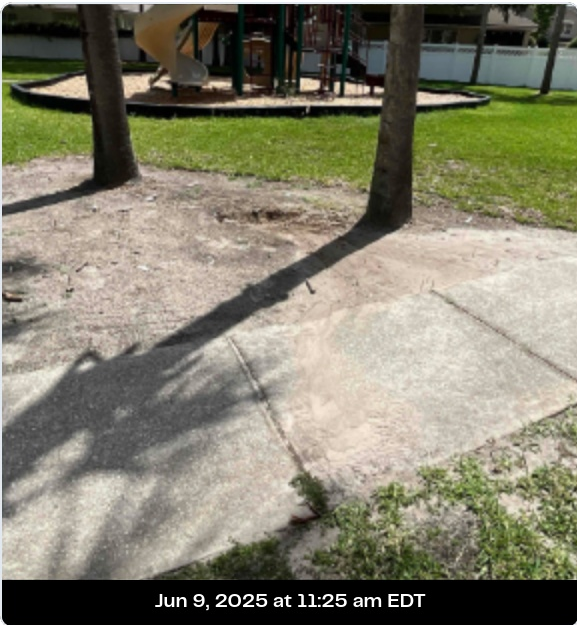
Branden J Marcinell June 9, 2025 11:25 AM EDT
Possible issue with irrigation. Investigate as needed.

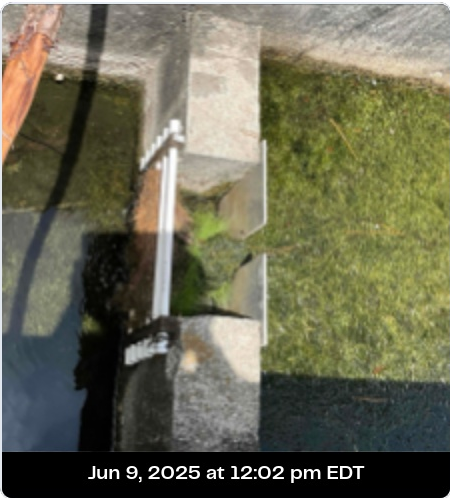
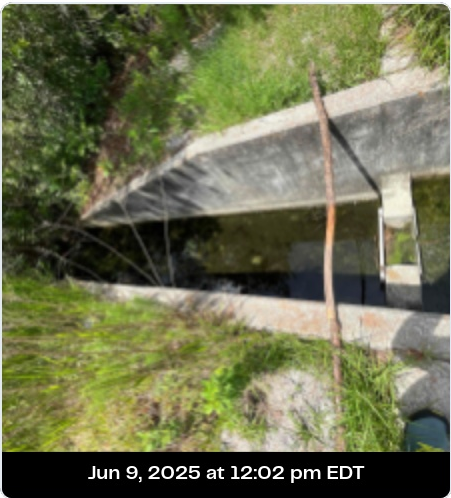
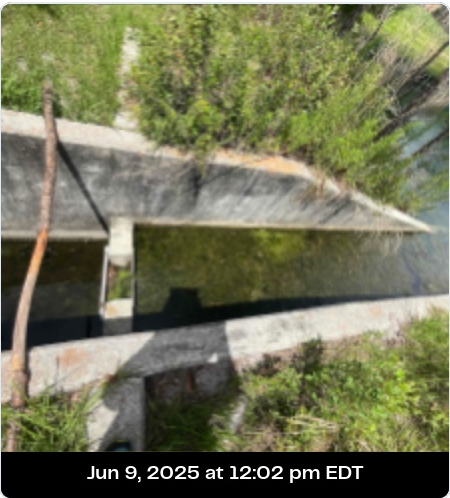
Weir blocked by vegetation and not functioning correctly. Remove vegetation and clean weir grate as needed.

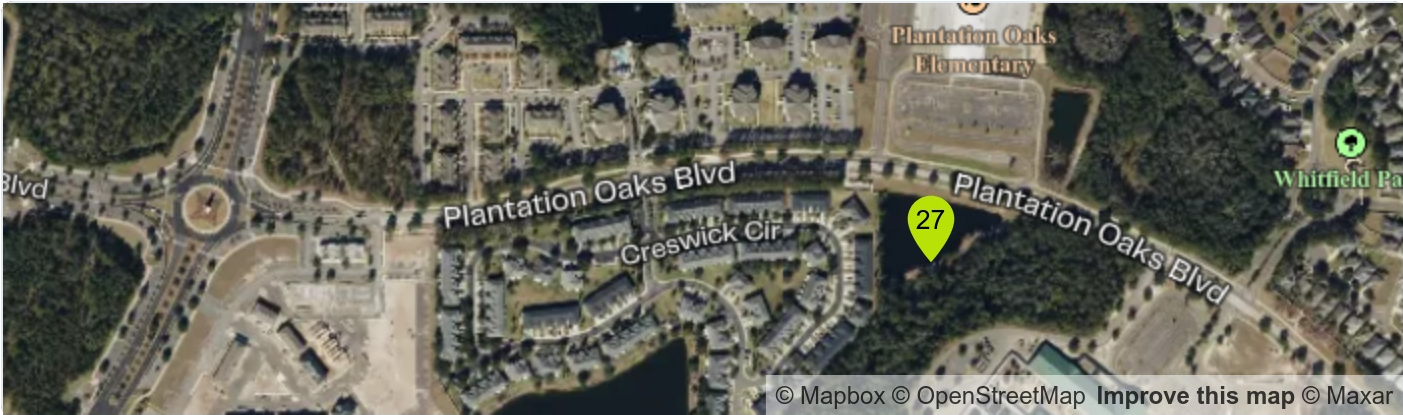
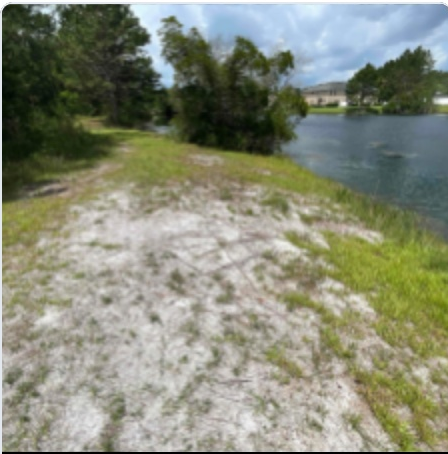
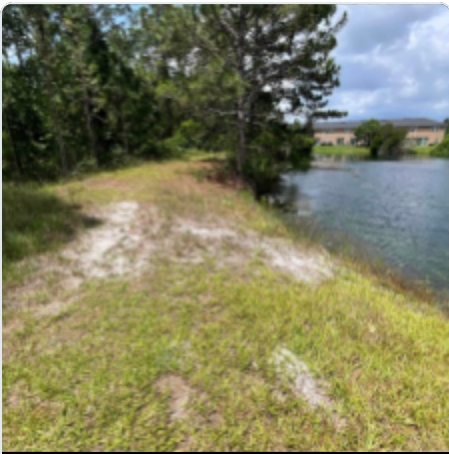
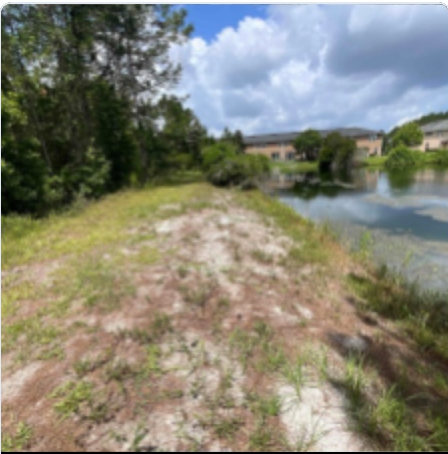
Branden J Marcinell June 9, 2025 12:10 PM EDT
Dead vegetation on Pond Bank. Reestablish vegetation to stabilize and protect against erosion.

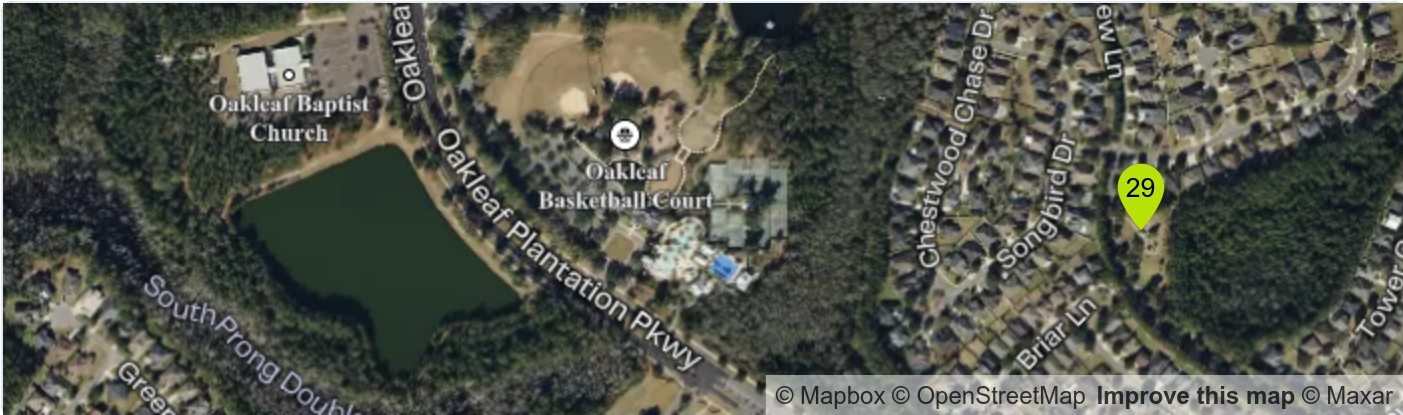
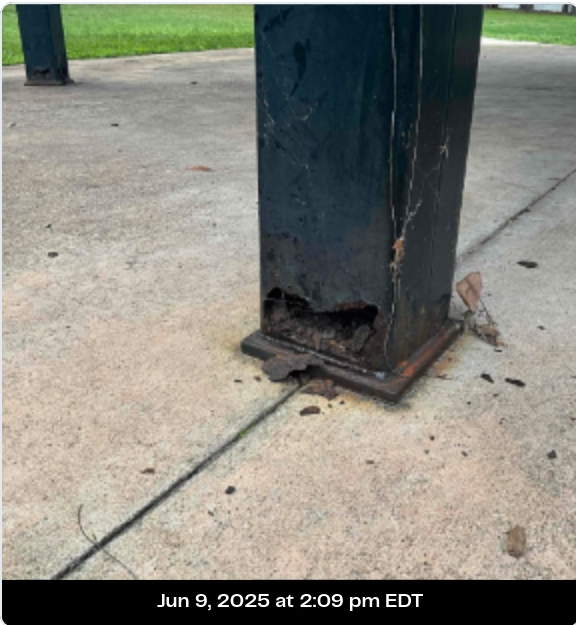
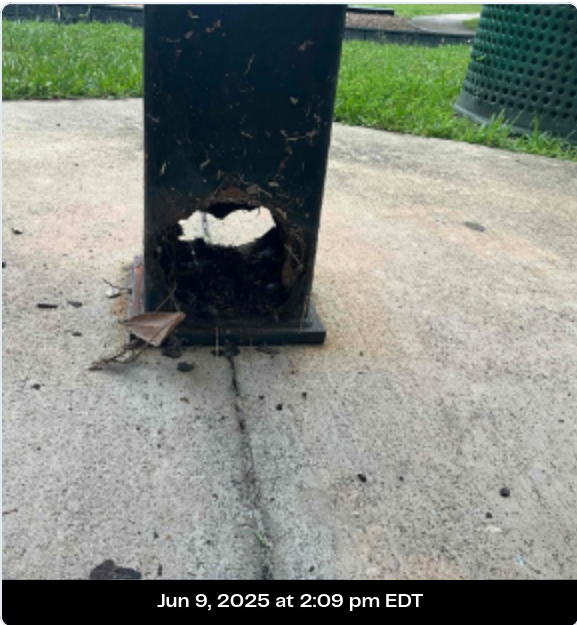
29

Branden J Marcinell June 9, 2025 2:09 PM EDT
Support post for pavilion area rotting out at the base. Advised inspection by structural engineer.

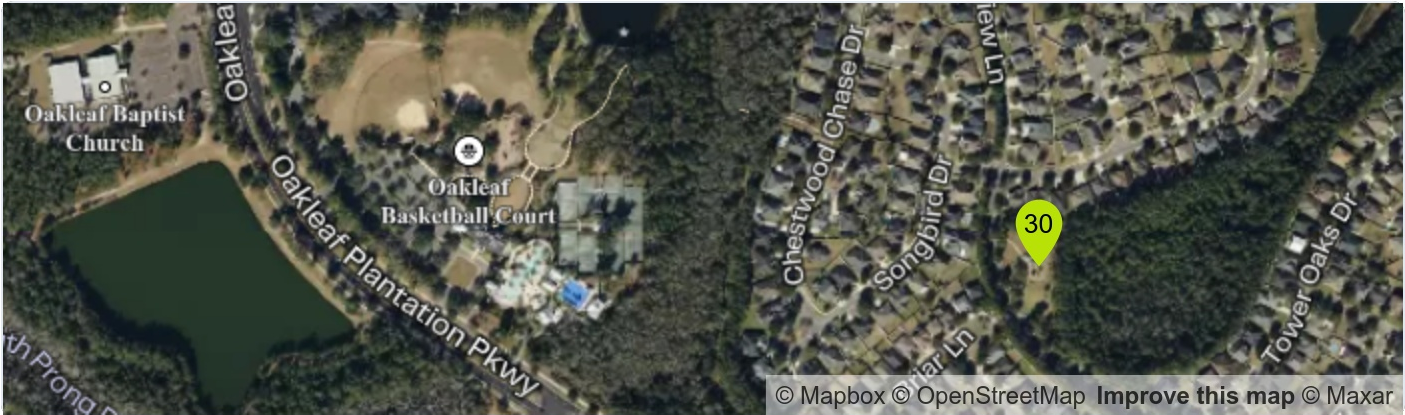
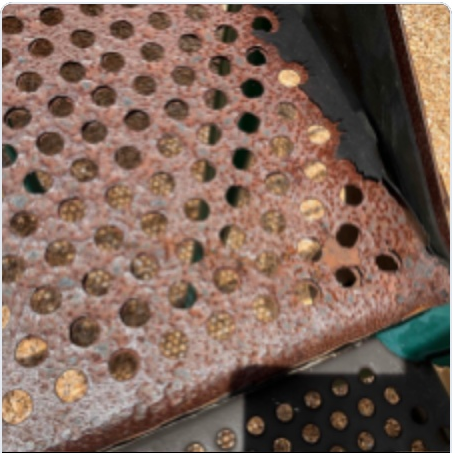
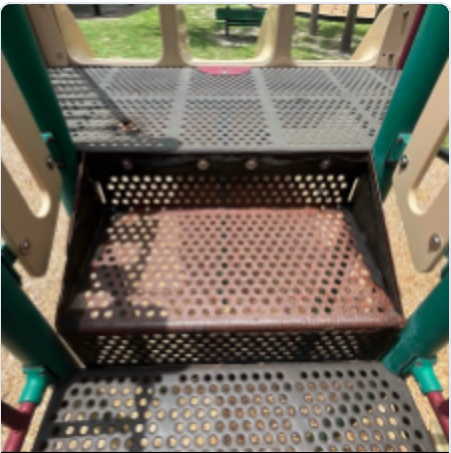
30

Exposed rusted metal on landing. Landing flexes under adult load. Multiple areas showing exposed rust and sharp edges. Advise protection against sharp edges.

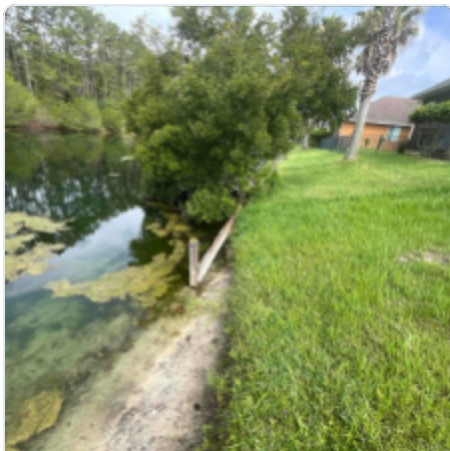
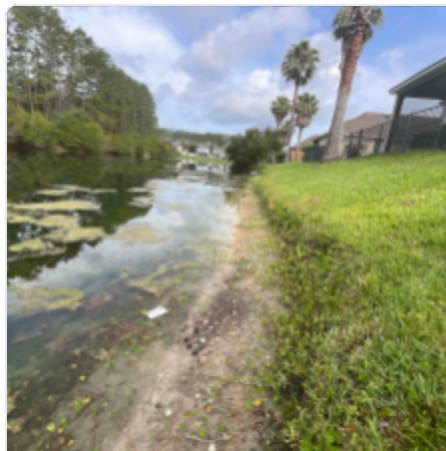
31

Large grade change at pond Bank. Multiple locations of erosion at property lines. Needs to be addressed due to the level of erosion observed.

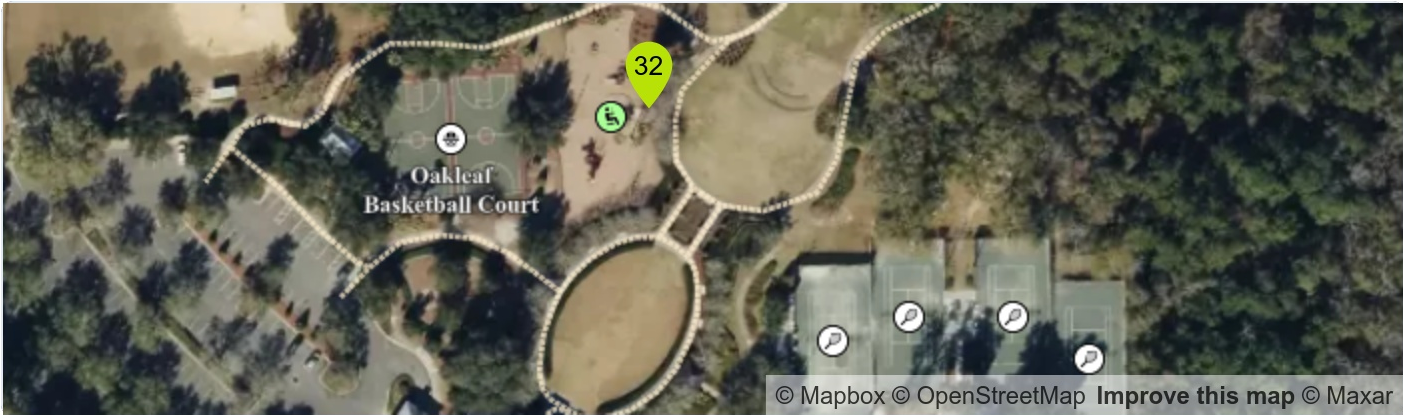
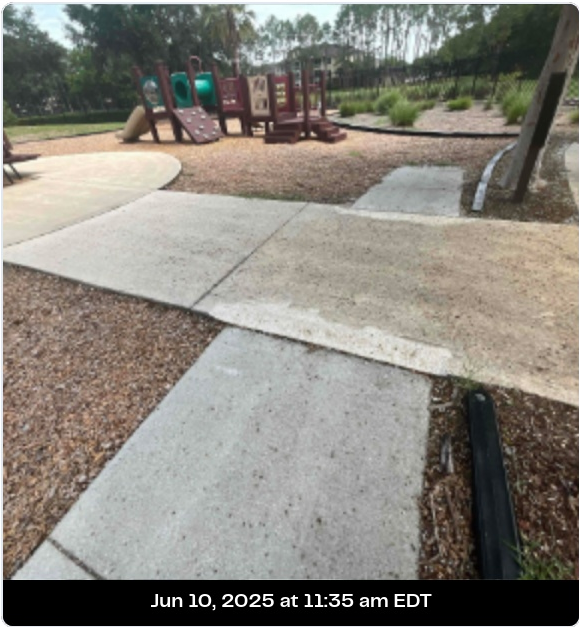
32

Abrupt grade change in sidewalk due to shaving. Advised painting, yellow, or softening grade change.

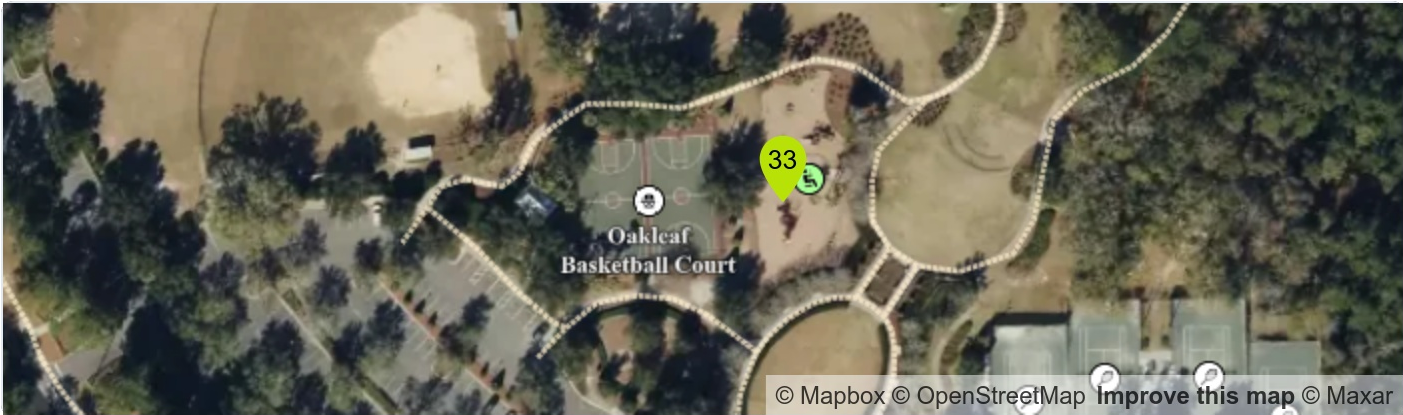
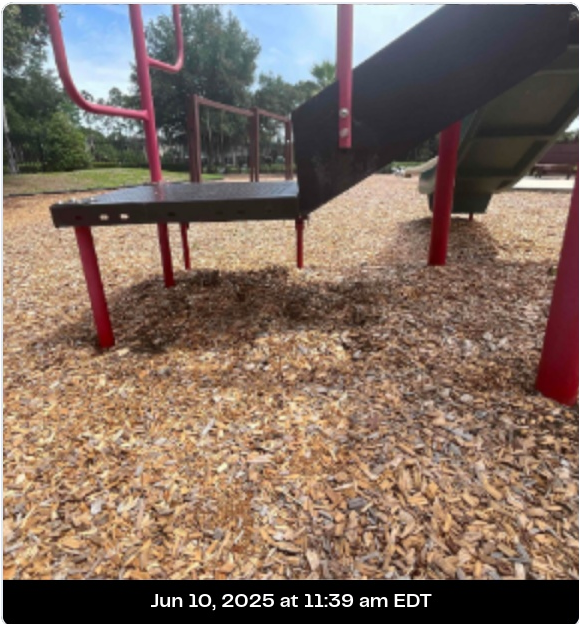
33

Branden J Marcinell June 10, 2025 11:40 AM EDT
Landing pad flexes at right corner before stairs. Advise adding corner support to keep from flexing and potential premature ware of stair pads.

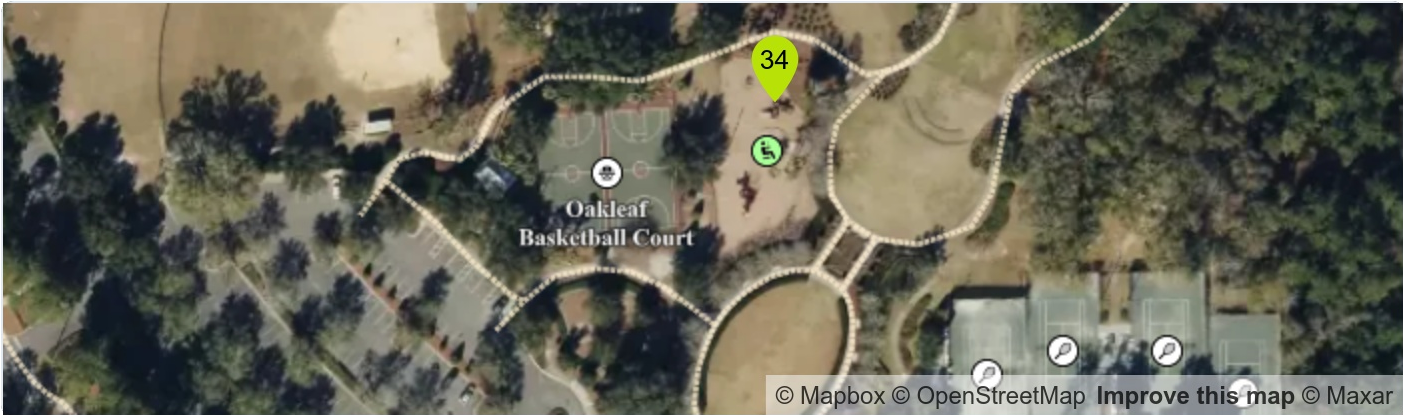
34

Branden J Marcinell June 10, 2025 11:44 AM EDT
Wooden support post in early stages of rot. Observe at future inspections for stability.

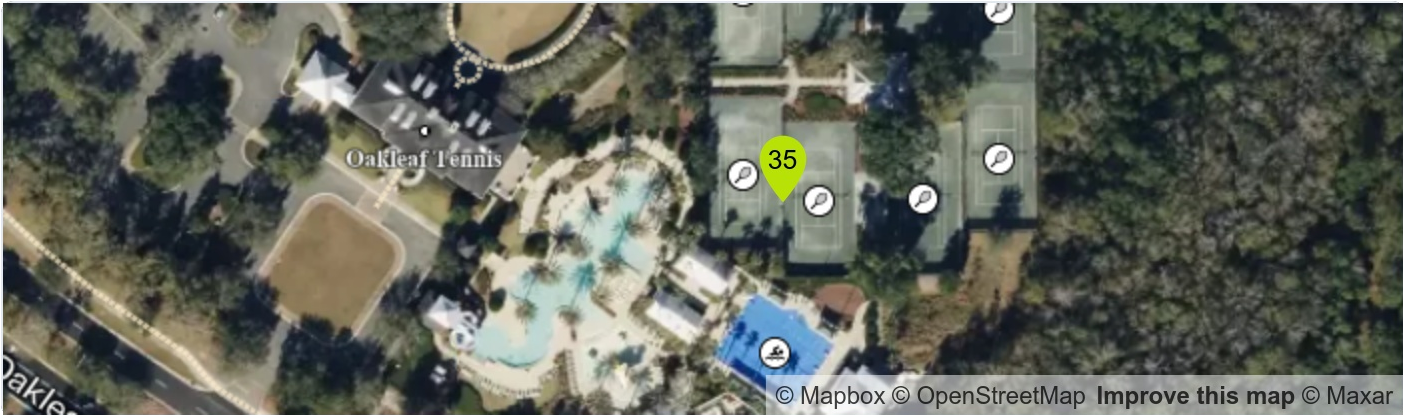
35

Erosion around irrigation. Adjust head to correct.

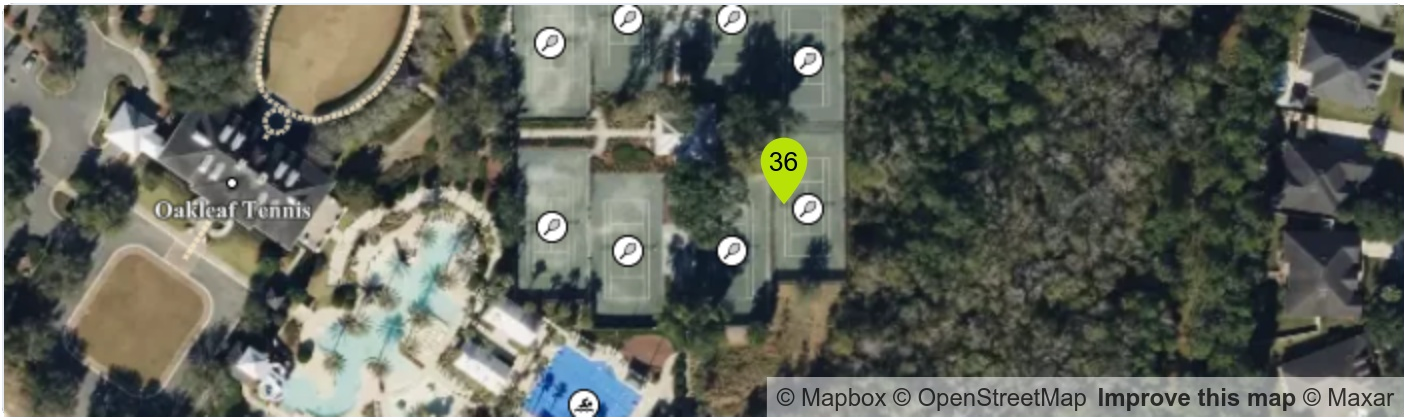
36 102 Observation

Branden J Marcinell June 10, 2025 11:55 AM EDT
Erosion around irrigation. Adjust head to correct.

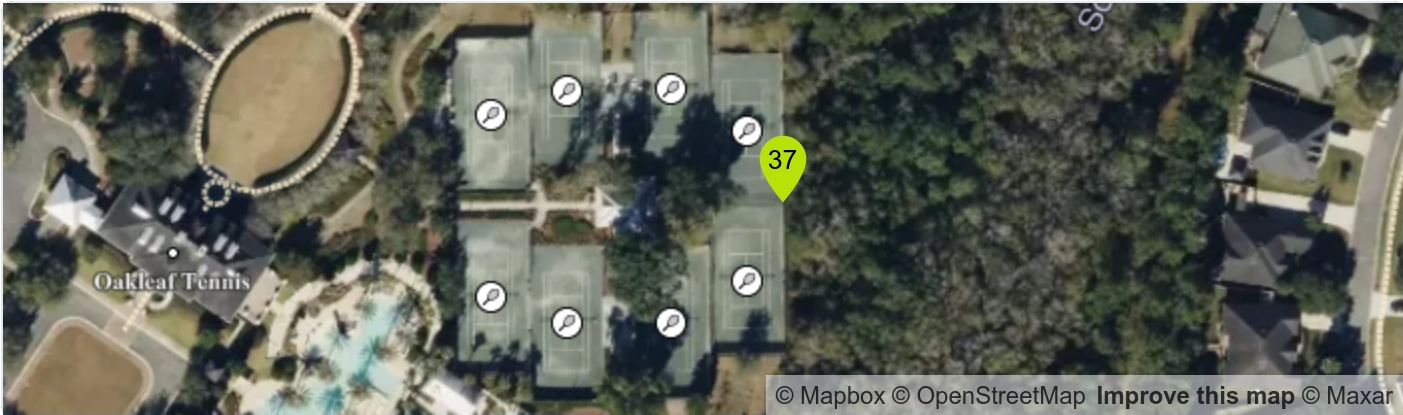
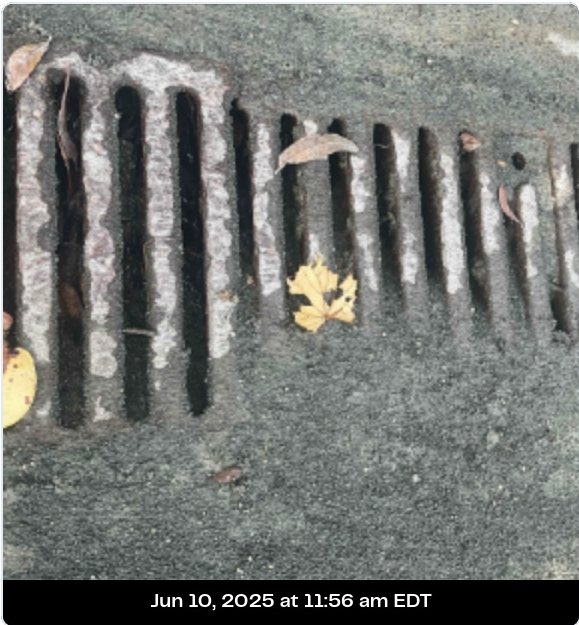
37

Branden J Marcinell June 10, 2025 11:57 AM EDT
Trench drain along court's edge clogged. Advise cleaning to improve drainage.

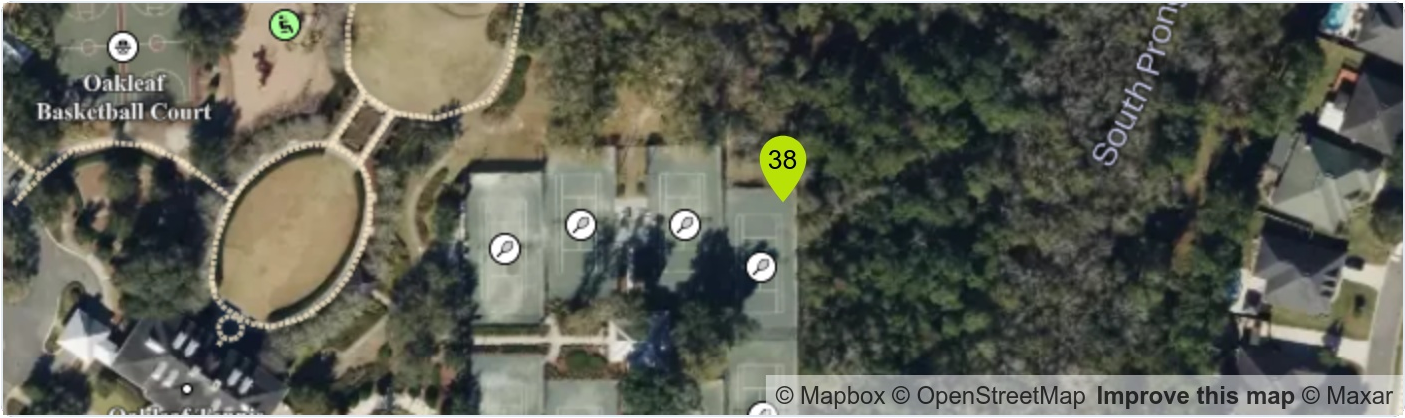
38

Branden J Marcinell June 10, 2025 12:02 PM EDT
Soft spot in clay surface. Repair / investigate cause.

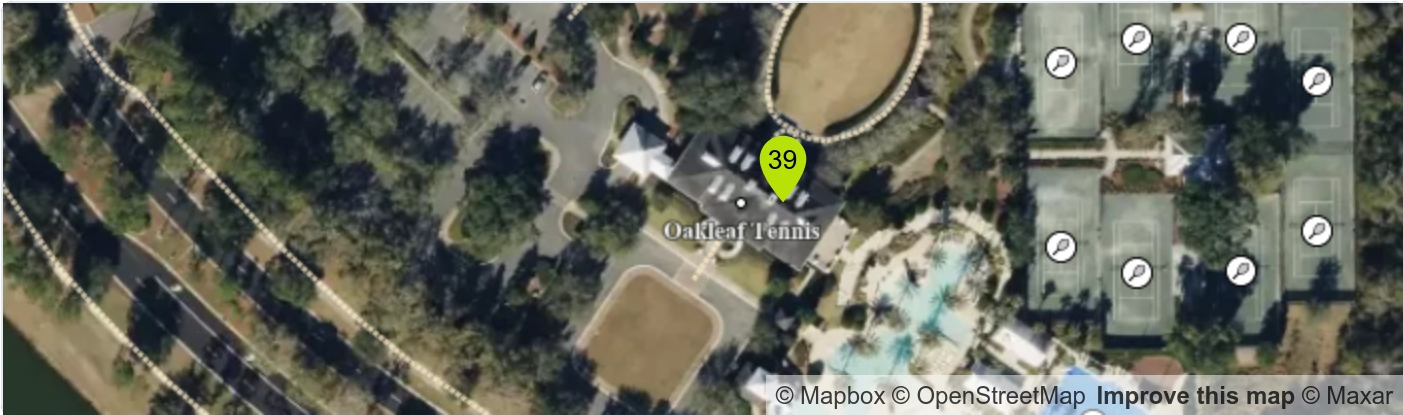
39

Branden J Marcinell June 10, 2025 12:03 PM EDT
Brick pavers minor settling around grate. Monitor in future inspections.

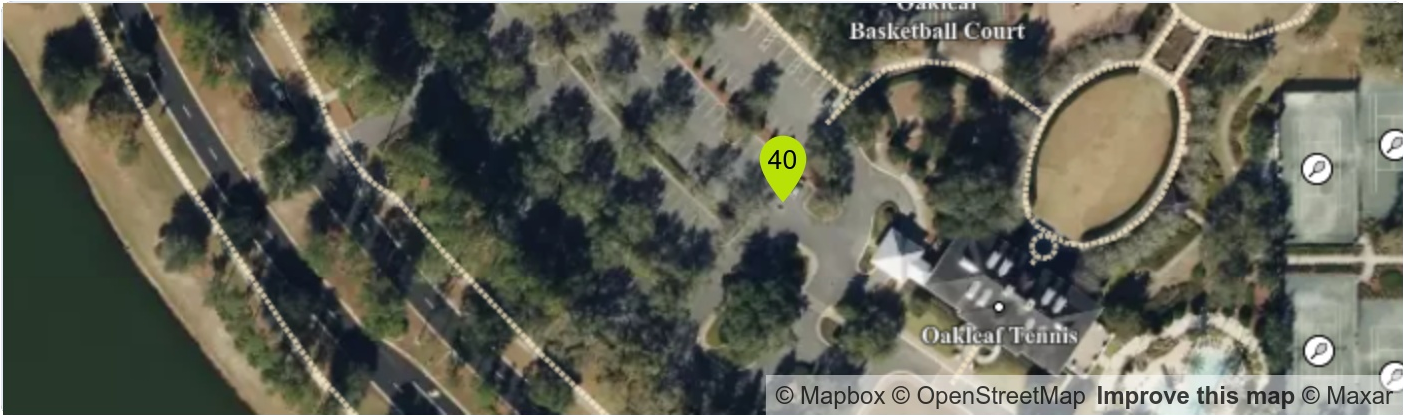
40

Pot hole next to inlet and parking lot. Possible issue with pipe underground. Patch hole with pavement or investigate cause for complete repair.

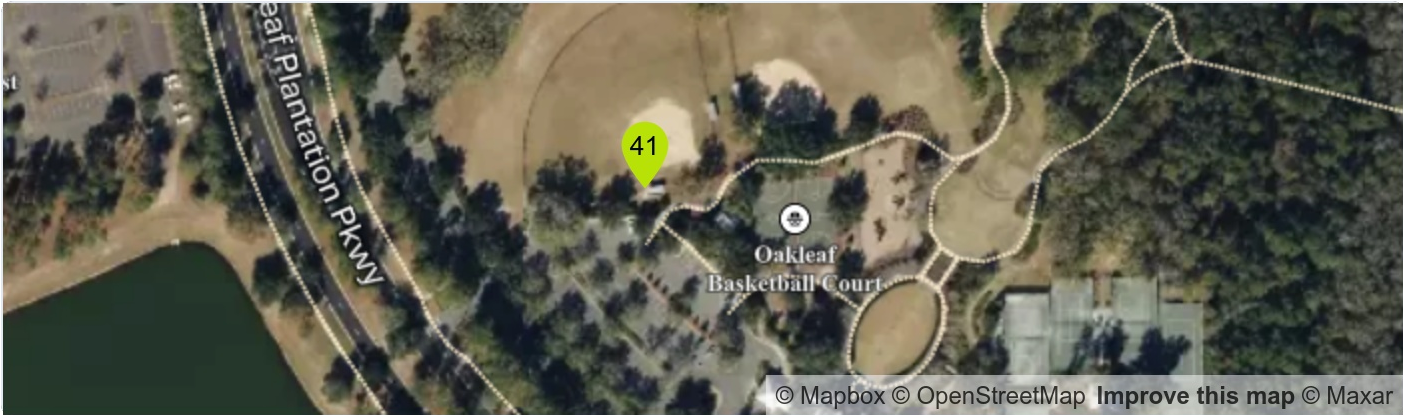
Concrete pad being undermine suggest fill and stabilize around corner to protect against cracking and erosion.

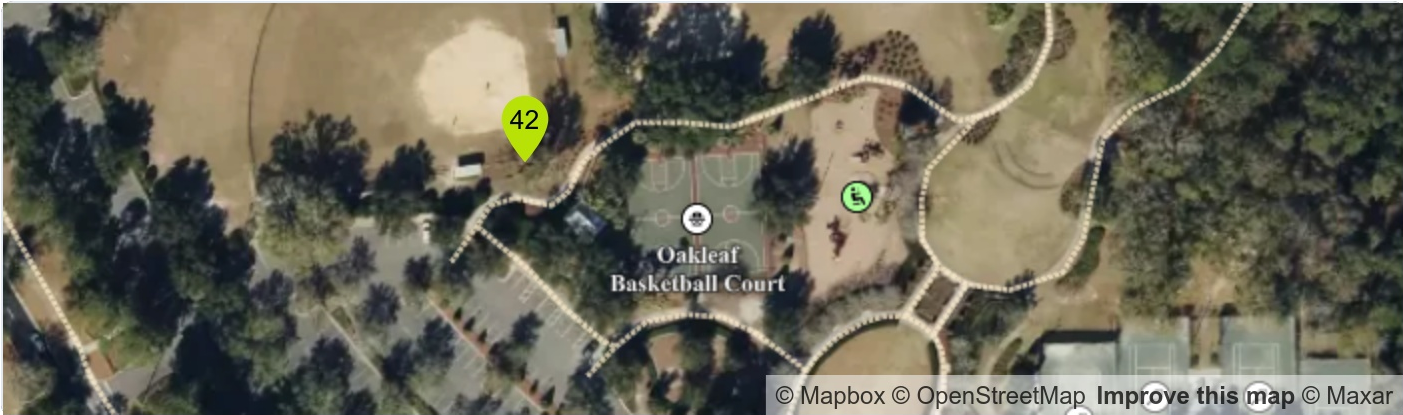
Branden J Marcinell June 10, 2025 12:57 PM EDT
Fence support down and broken. Repair and reattach for stability.

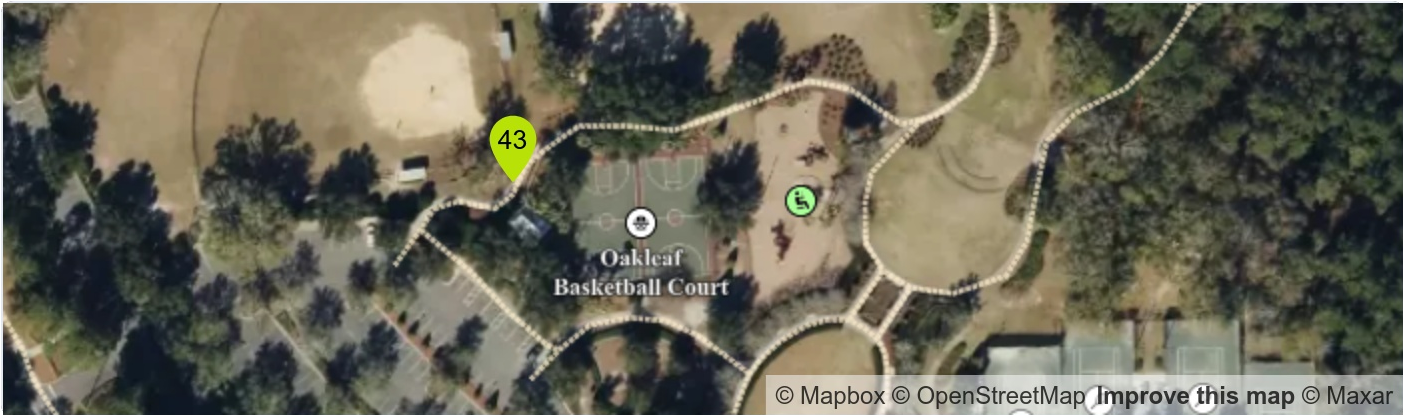
Broken sidewalk with trip hazard. Repair flush with existing sidewalk.

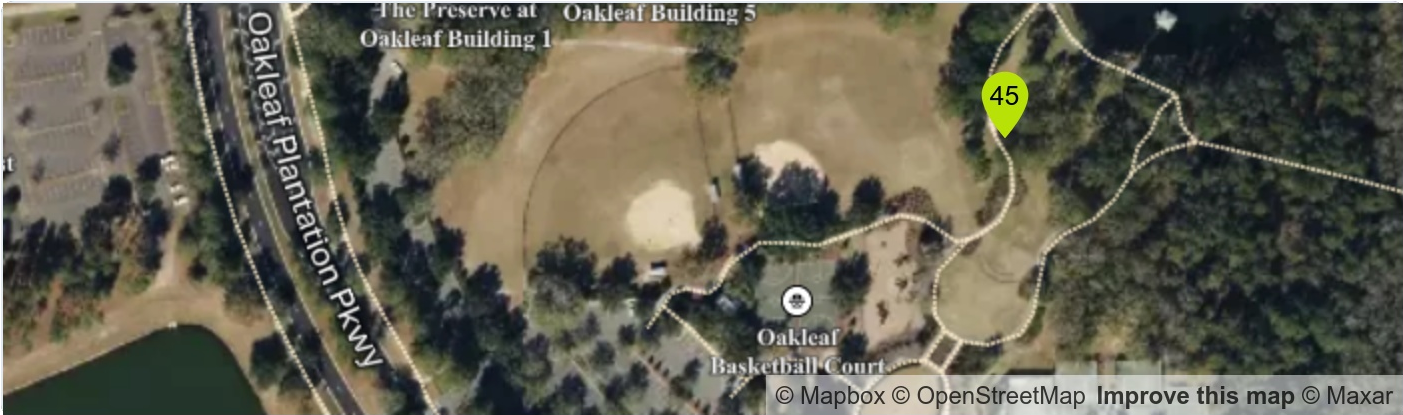
Broken sidewalk with trip hazard. Repair flush with existing sidewalk.

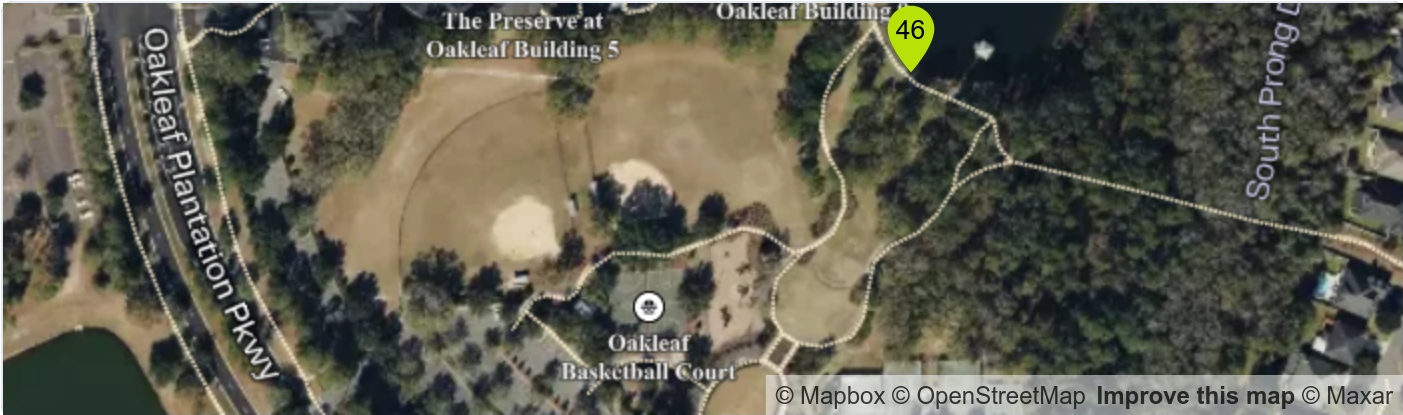
Branden J Marcinell June 10, 2025 1:03 PM EDT
Broken sidewalk with trip hazard. Repair flush with existing sidewalk.

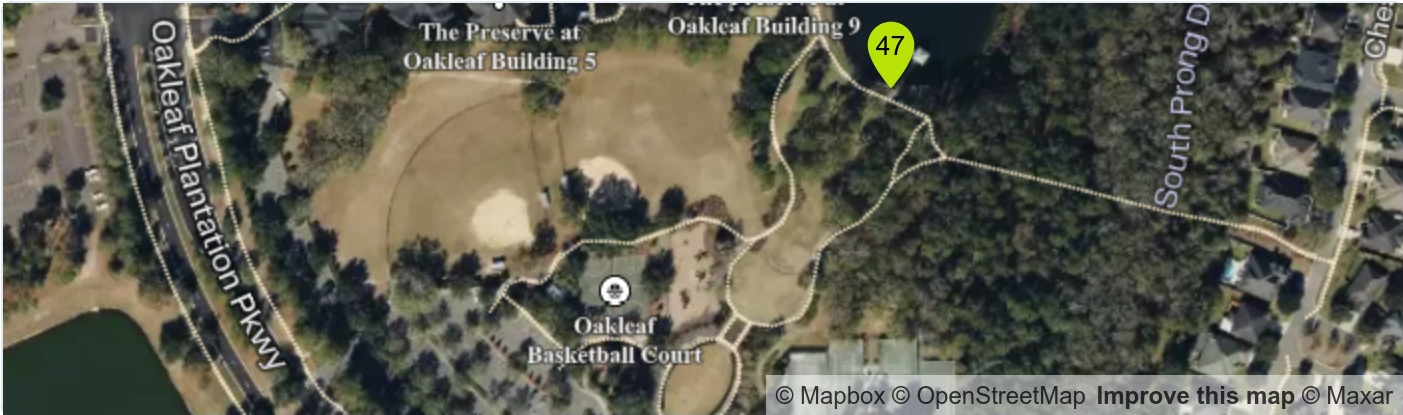
Branden J Marcinell June 10, 2025 1:06 PM EDT
Erosion underneath sidewalk. Backfill to protect against settling and separation or monitor for worsening condition.
